Environmental Compliance in the Petrochemical Industry in the Sarnia Area

Report of the Environmental SWAT Team:
Sarnia Inspection Sweep 2004 - 2005

April, 2005

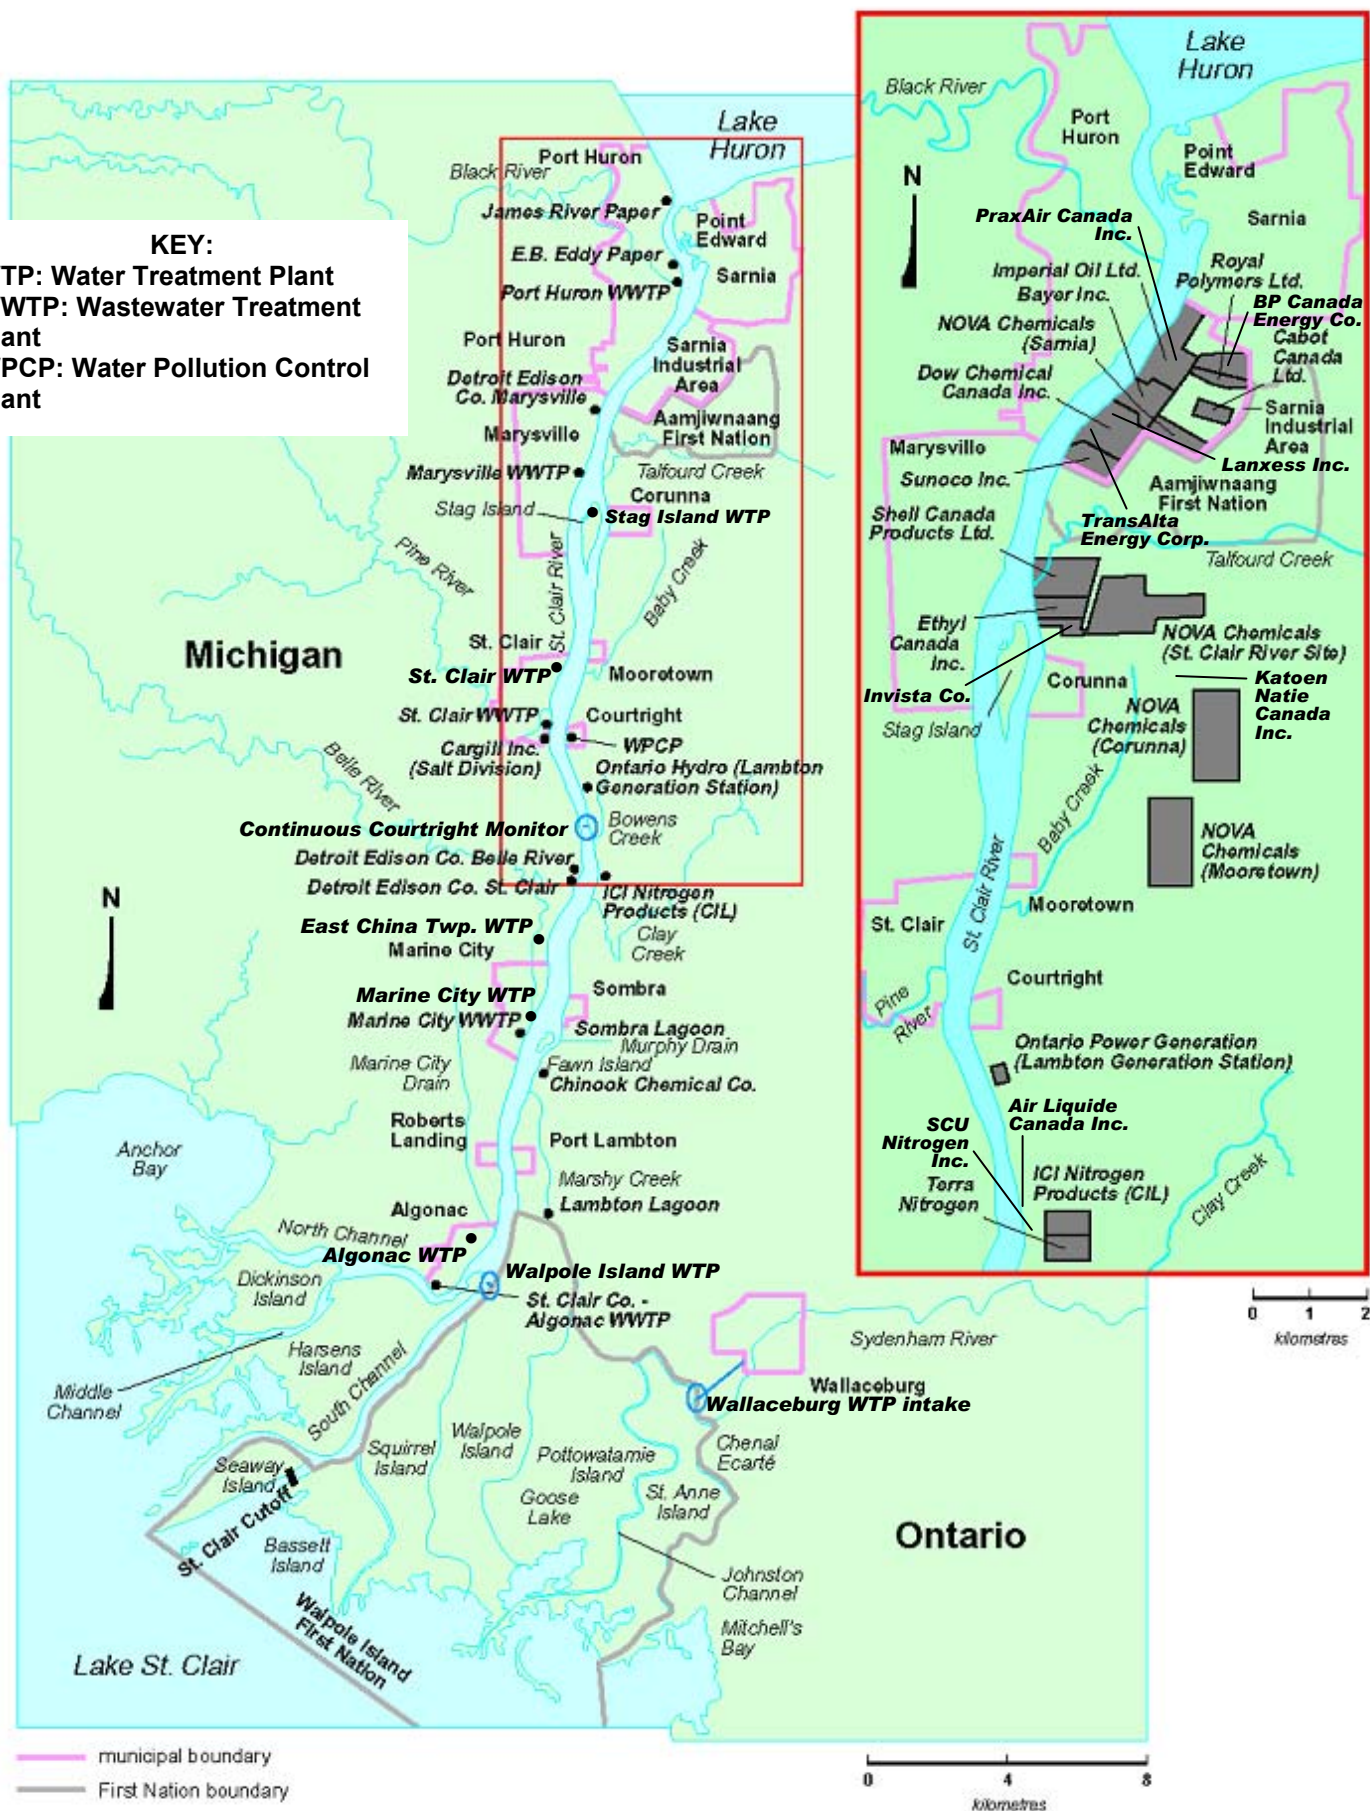
Figure 2: Facilities Inspected

Twenty-one of the facilities are located in Sarnia and 14 are located in St. Clair Township. An aerial view of the area is provided in Figure 2, showing the location of the facilities inspected during the sweep.
